INDUSTRY ALERT

FOLCB Neutral Terminal – Incorrect Configuration Identified

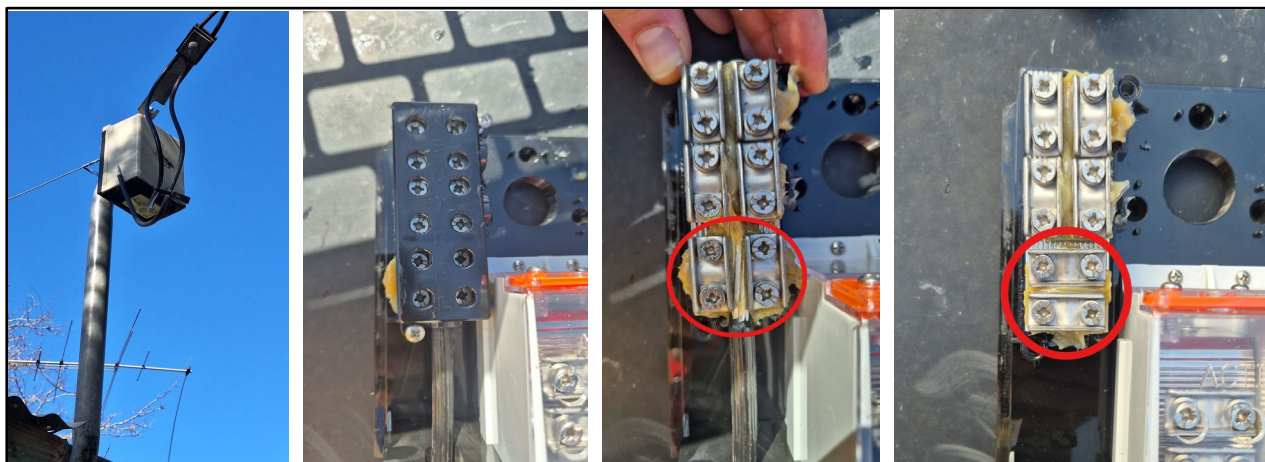
- While performing a service connection, a VESI crew discovered that the FOLCB neutral terminal was incorrectly configured, with clamp plates installed vertically rather than horizontally.
- This incorrect configuration prevented proper mechanical and electrical connection, creating a potential neutral integrity safety hazard.

- Incorrectly terminated neutral conductors increase the risk of electric shock or other harm to both occupants and workers.
- Responsibility for ensuring correct installation and its configuration rests with the REC/electrician.

- Distribution workers will not interfere with customer installation equipment. Supply **will not be connected** if the equipment is incorrectly installed or configured.
- RECs/electricians must ensure all equipment is correctly installed and configured to allow safe access and termination of cables, maintaining electrical integrity.
- If the site is found unsafe or the equipment is not compliant, the connection will be refused, and any delays or costs remain the responsibility of the customer and their REC/electrician.
- Electricians are encouraged to inspect and verify all installation equipment prior to requesting supply, and where issues are found, rectify immediately or refer to the manufacturer.
